# Cleawox Lake, Oregon: The Coastal Sands of Cultural Omission

Douglas W. Larson

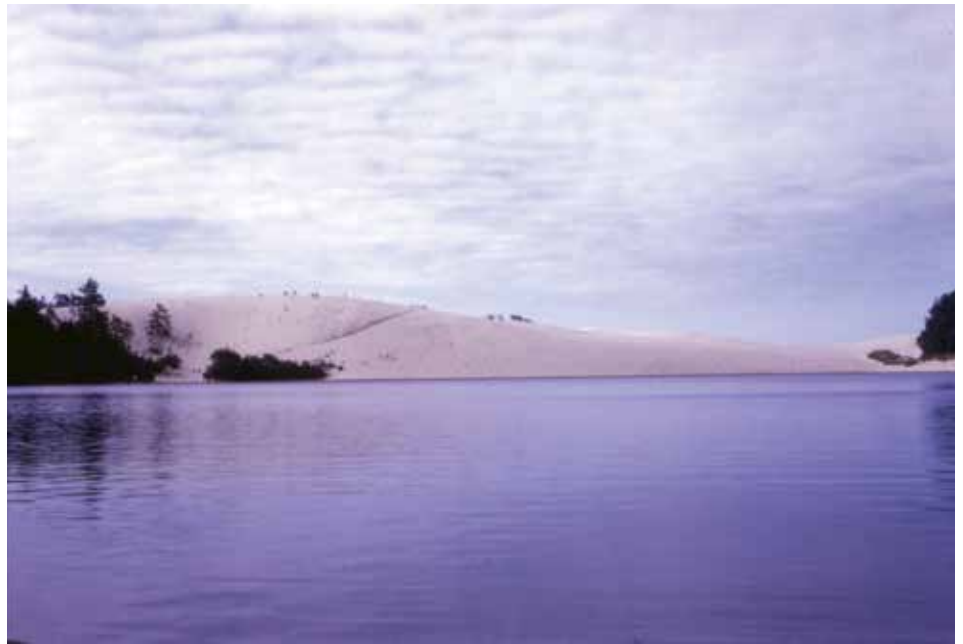
Figure 1. Cleawox Lake and south-shore dune, July 1968. Visitors are seen climbing a trail that cuts diagonally across the dune's slip face. Photo by the author.

Nearly 50 years have passed since I first plied the crystal clear waters of Oregon's Cleawox Lake, collecting water samples while marveling at the towering, steep-faced sand dune rising majestically along the lake's south shoreline (Figure 1). The dune, referred to as one of the largest single dunes in the world, is part of the vast Coos Bay dunal sheet that extends for about 80 kilometers along Oregon's central Pacific Coast. Winding along this coastal region is a chain of maritime lakes, most of which are sand-barrage lakes including Cleawox (Figure 2). As their designation implies, these lakes were originally coastal streams impounded by ocean sand dunes advancing inland. Cleawox Lake owes its existence largely to its imposing south-shore dune that blocked the lake's drainage to the ocean (Figure 3).

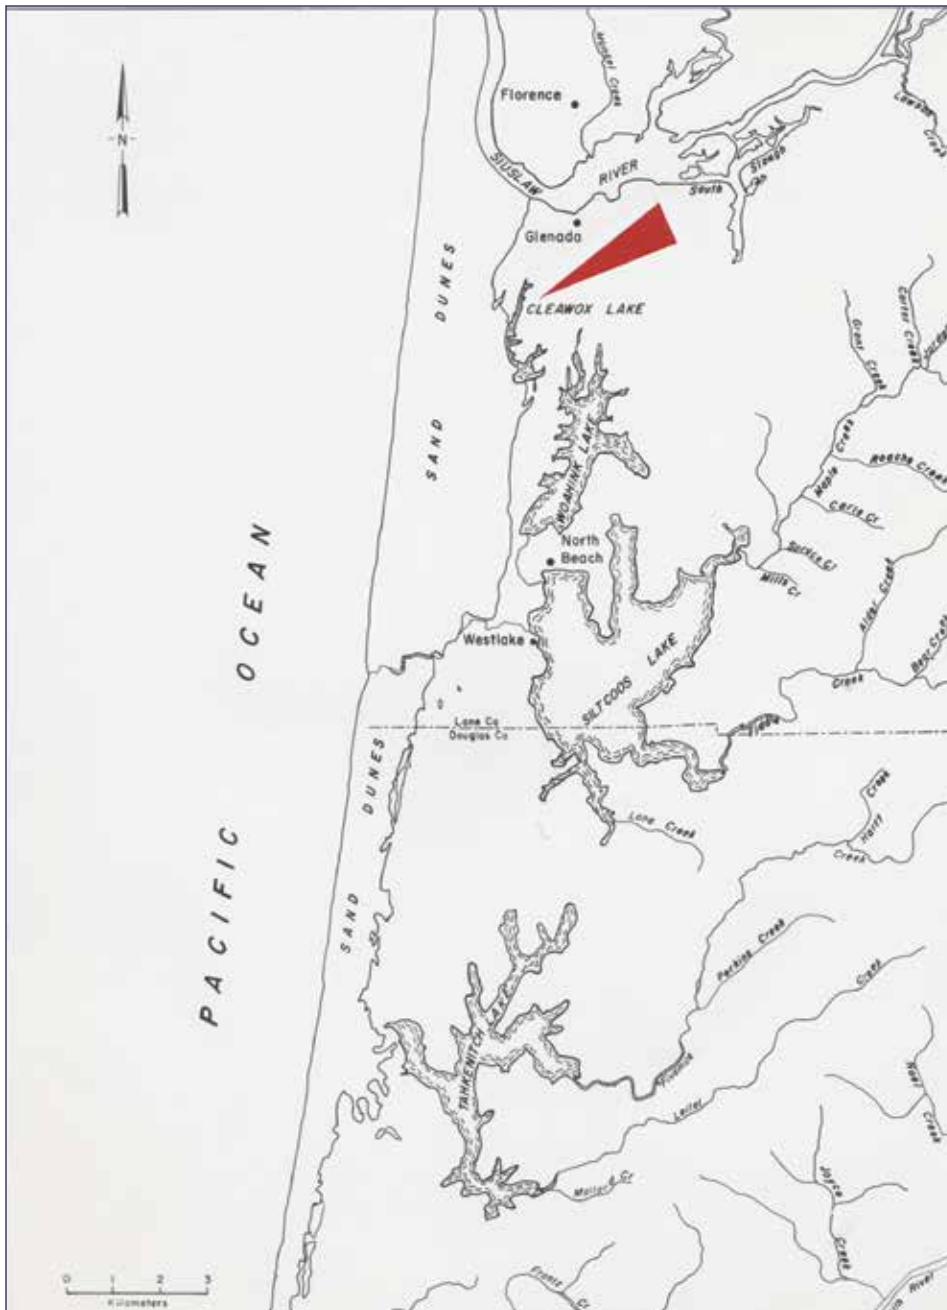
Figure 2. Map showing Cleawox Lake and other sand-dunal lakes.

Despite its dunal impoundment, Cleawox Lake continues to drain through a small, intermittent creek that flows northward before more or less disappearing into a complex of dunal sands, riparian vegetation, and wetlands somewhere between the lake and the Siuslaw River (Figure 2). The extent of drainage into the Siuslaw River is uncertain. Creek outflow has steadily diminished over the years due to various obstacles in the channel, principally beaver dams and proliferating vegetation planted to stabilize dunes. Efforts to clear the waterway and improve drainage have largely failed. This restricted outflow

Inflowing drainage is derived from a relatively small area covering about four square kilometers (Johnson et al. 1985). Surface inflows include Buck Creek, which enters near the upper end of the lake's two-kilometer-long northerly arm (Figure 2), and several intermittent unnamed rivulets.

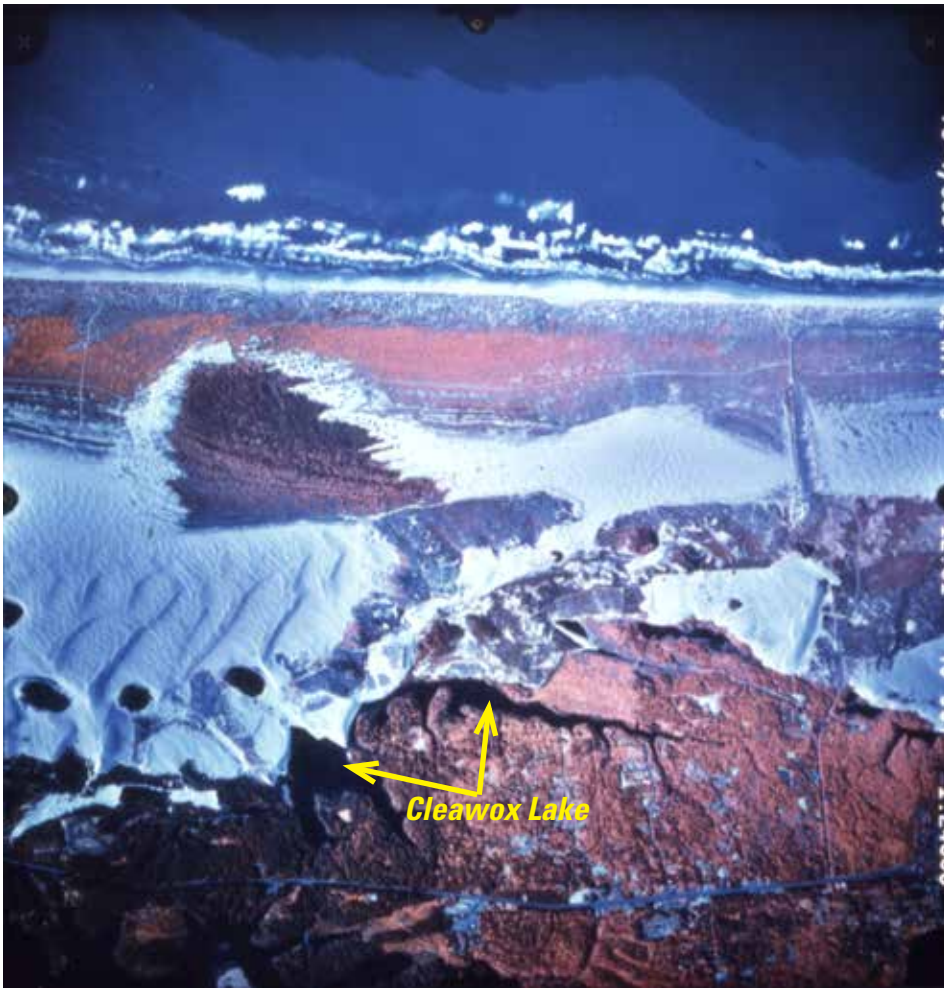
Figure 3. Vertical aerial photo of Cleawox Lake and adjoining dunes, color infrared, October 13, 1978, 1200 hours. Scale=1:24,000. Source: U.S. Army Corps of Engineers.

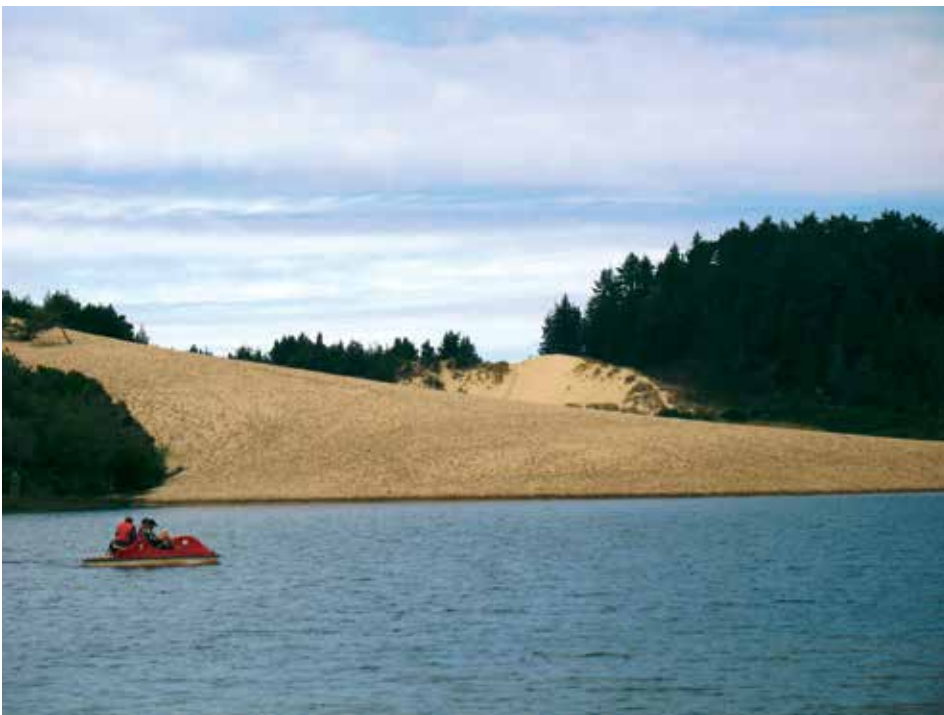
Figure 4. South-shore dune, August 16, 2013. Photo by the author.

During a recent visit to the Oregon coast to photograph lakes, I stopped at Cleawox Lake to once again observe the lake's condition and shoot the dune, so to speak, as I had done many times in years past. What my camera captured was a forlorn remnant of a scenic wonder (Figure 4), its former grandeur lost forever and a large portion of its luminous sand lying submerged in the lake. Although wind and other natural processes contributed significantly to the dune's in-lake encroachment, humans bear much of the responsibility for the irreversible impact to dune and lake. The main damage appears to have taken less than 50 years, the result of (1) human failure to recognize the dune's vulnerability and its fragile structure, (2) failure of individual dune-users to perceive how their self-serving actions affected the common good, and (3) failed stewardship on the part of federal and

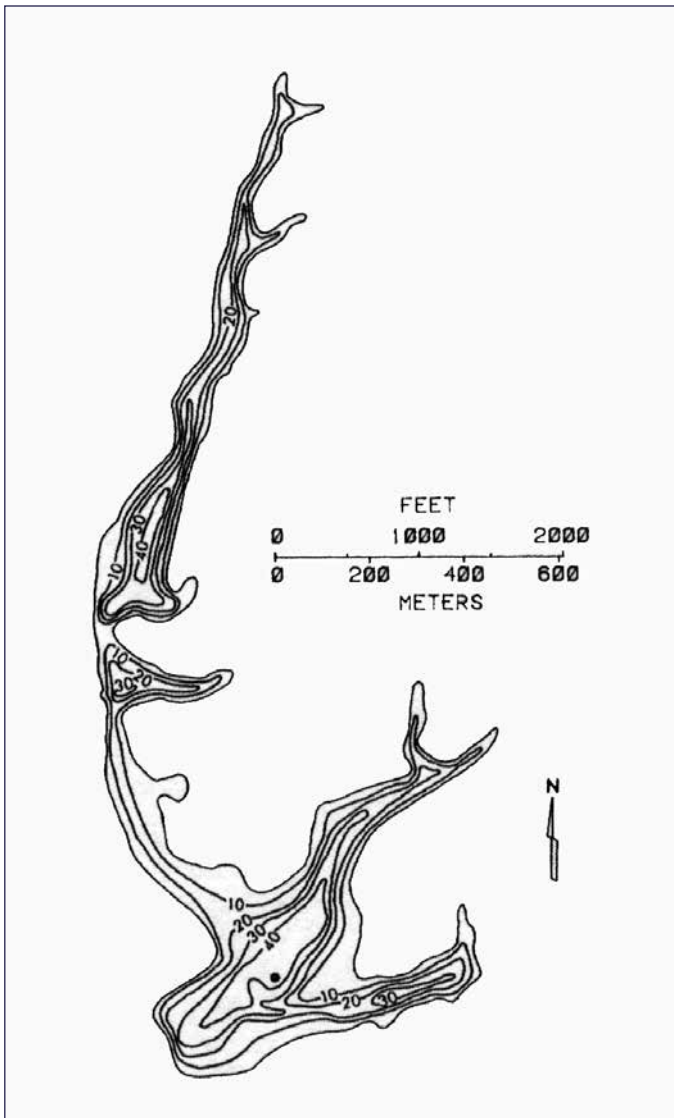
Figure 5. Bathymetric map of Cleawox Lake. Maximum recorded depth (15 meters) is indicated by a dot near lake center. The map is based on depth soundings by the Oregon Game Commission in March 1960. Source: Saltzman 1961.

The lake's current morphometry is largely unknown. The lake has steadily filled with sand since the lake's complete bathymetry was last mapped 54 years ago, in March 1960 (Figure 5). Back then, the few morphometric variables reported included the lake's surface elevation (23 meters above mean sea level), surface area (33 hectares), volume (1,391 acre-feet), and maximum depth (15 meters). Shoreline length was approximately eight kilometers.

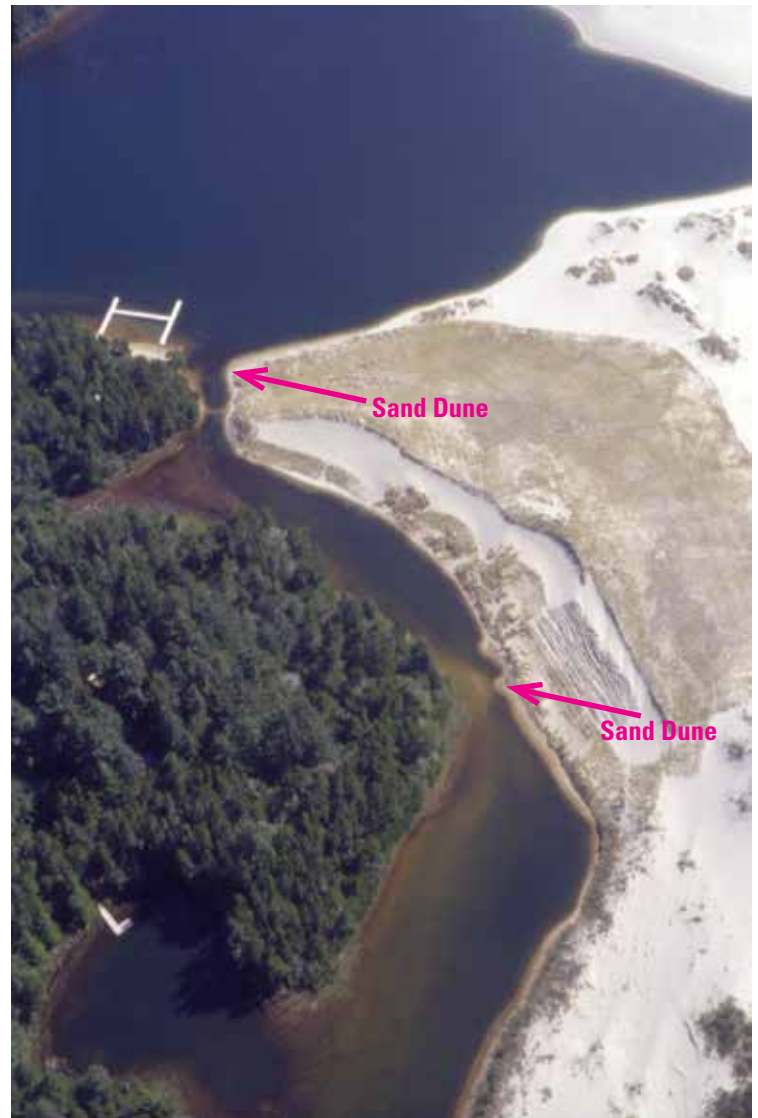
Figure 6. Sand has nearly blocked the lake's northerly arm where the arm meets the lake's main body and at a second point about 100 meters upstream, as indicated by arrows, September 1989. Photo by the author.

More recently, in January 2008, Witter and others (2008) obtained depth soundings along five transects extending across the western one-third of the main lake and along three transects across the lake's northerly arm. A maximum depth of about 12 meters was recorded along the transect positioned about 140 meters from shore. Closer to shore, however, shallower waters indicated substantial shoaling due to sand-dune encroachment. Shoaling was also evident in the arm, with depths being somewhat less than they had been in 1960. Then, the distance across the arm at its juncture with the main body of the lake was about 120 meters and the depth at that point was 3-6 meters (Figure 5). But by 1980, the arm was essentially isolated from the main body by an advancing tongue of dunal sand. Dredging during the mid-1980s removed the sand, presumably for the purpose of allowing boats to enter the arm (Witter et al. 2008). Still, aerial photos taken in 1989 indicated renewed shoaling of the arm at its juncture with the main body and at a second point about 100 meters upstream (Figure 6).

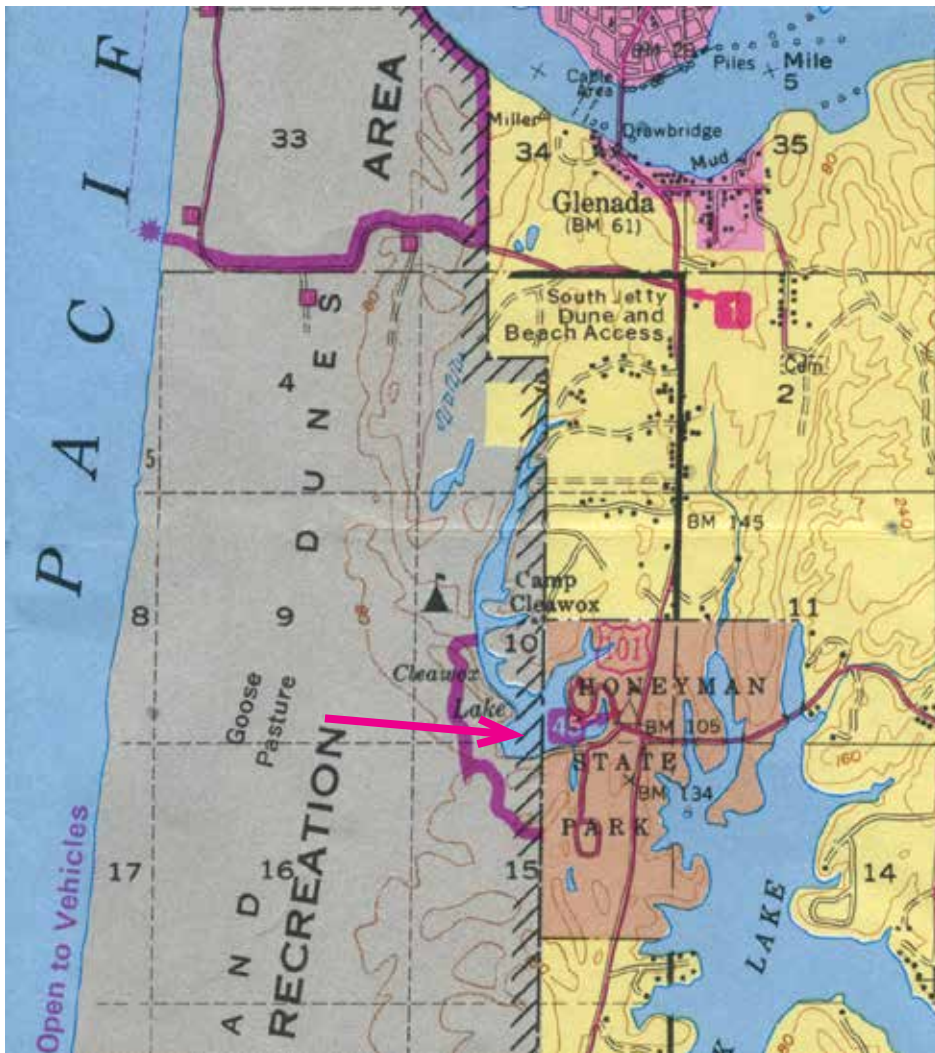
Figure 7. Map, dated 1981, showing location of Cleawox Lake relative to Honeyman State Park and the Oregon Dunes National Recreation Area. Purple boundary along west shore of the lake indicates lake closure to off-road vehicles. Source: Oregon Dunes NRA, Siuslaw National Forest, U.S. Forest Service.

Cleawox Lake is surrounded almost entirely by public lands administered by both the federal government and the State of Oregon. Much of the lake lies within the Oregon Dunes National Recreation Area (NRA), managed by the U.S. Forest Service. Land south and east of the lake is the Jessie M. Honeyman Memorial State Park, administered by the Oregon Parks and Recreation Department (Figure 7).

annually. More than 400 bird species are also present, a few of which are threatened, notably the snowy plover. The Jessie M. Honeyman Memorial State Park was constructed between 1935 and 1940 by the Civilian Conservation Corps. The park, covering about two square kilometers (Figure 7), offers visitors a variety of recreational opportunities, including overnight camping (200 campsites), swimming, fishing, boating, hiking, bird-watching, ATV access, dune-buggy rides, and sandboarding. Other shoreline facilities include a Girl Scout camp (Camp Cleawox), a stone-and-log concession building built in 1938 as the Cleawox Lake Bathhouse, and the park office building constructed in 1936-37 as the park caretaker's house and garage.

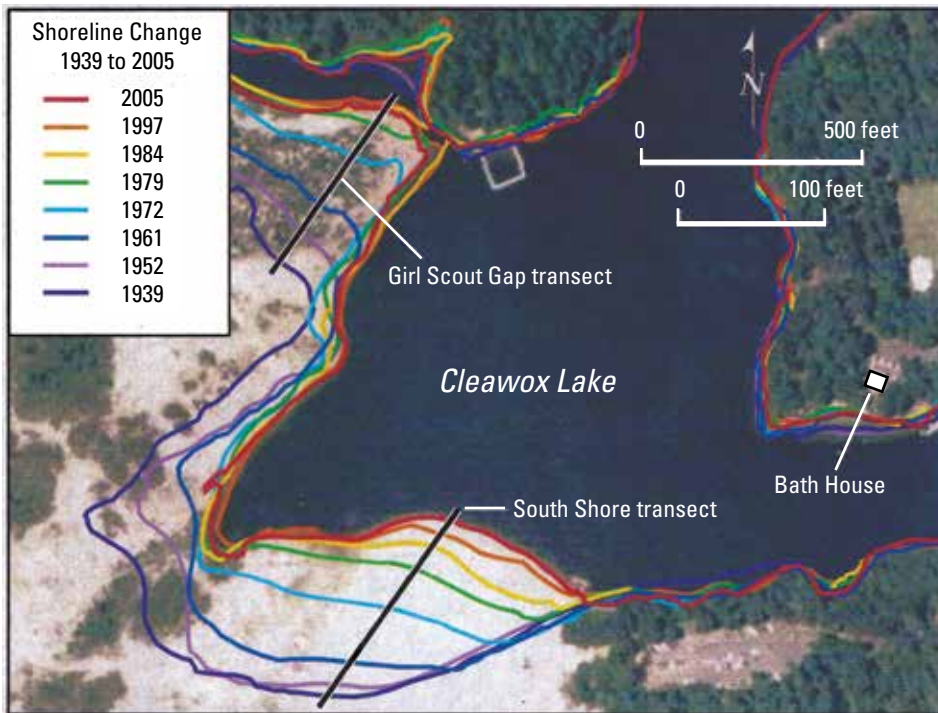
Figure 8. Illustration showing northeast migration of south-shore dune between 1939 and 2005. Illustration printed with permission from R.C. Witter, U.S. Geological Survey and lead author of 2008 publication by R.C. Witter, G.H. Grondin and J.C. Allan.

the entire basin. Since 1939, the south-shore dune has migrated northeastward for a total distance of about 150 meters at the average rate of about 2.3 meters annually (Figure 8). The rate of migration was highest between 1972 and 1979, averaging between 3.9 and 4.8 meters per year. Dune migration has since diminished somewhat, averaging around 1.5 meters or less per year between 1984 and 2005 (Witter et al. 2008). Nevertheless, the process continues as human intervention in this rare and fragile environment prevails.

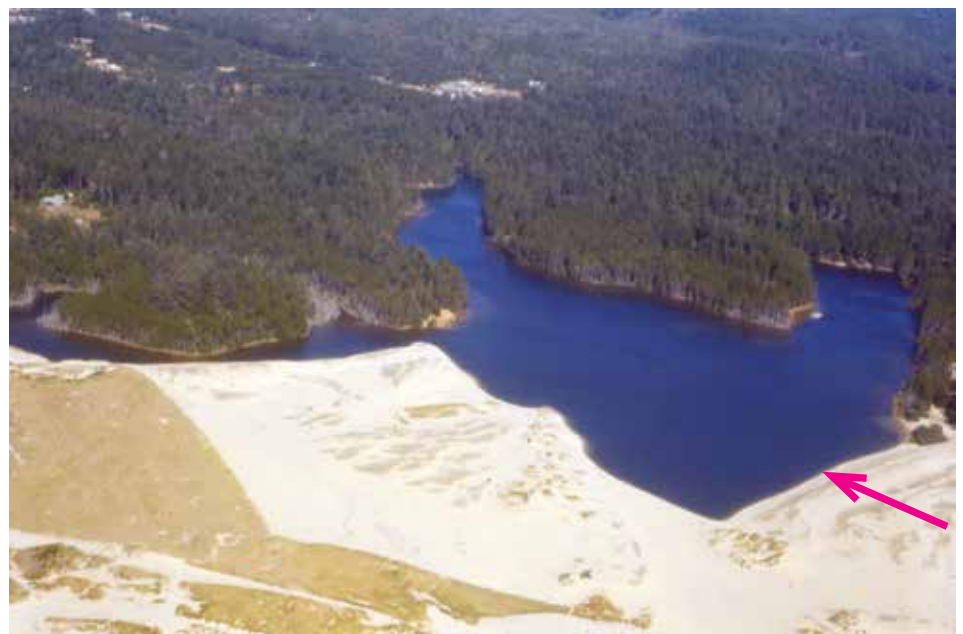
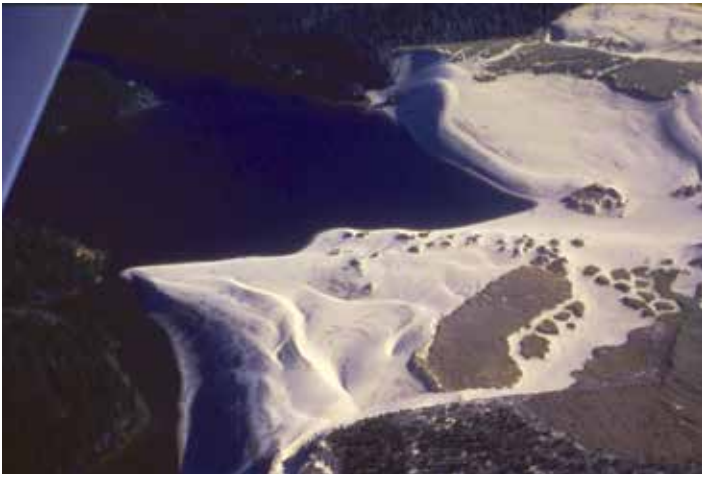
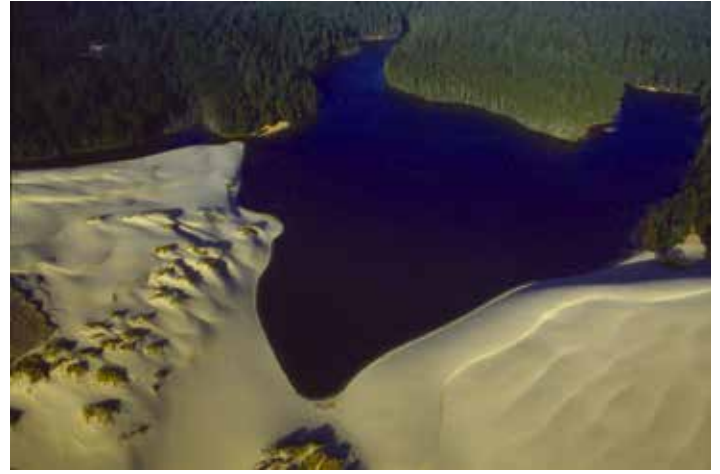
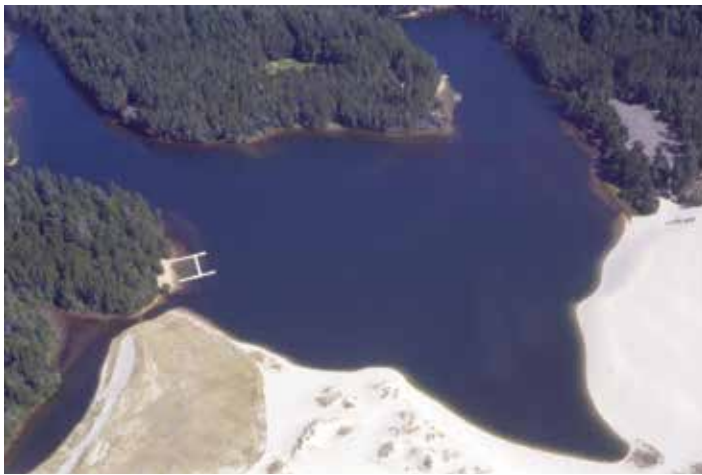
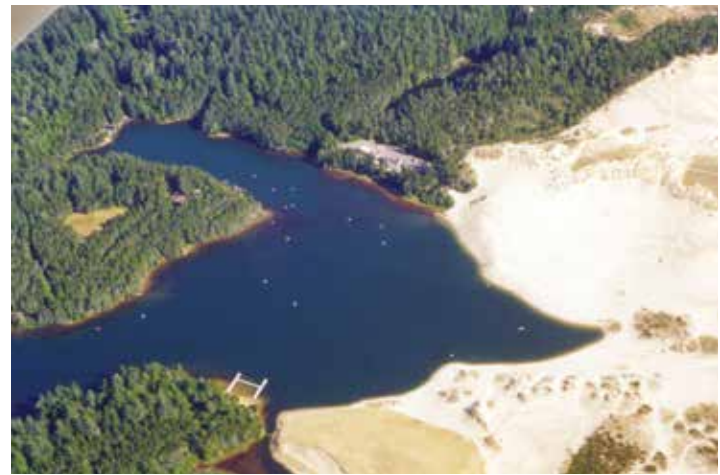
Figure 9. Aerial photo of Cleawox Lake, September 1973. Arrow indicates south-shore dune. Photo by the author.

Figure 10. Aerial photo of Cleawox Lake, November 1978. South-shore dune visible in photo's upper right-hand corner. Note the dune's arching oblique ridge that has developed. Photo by the author.

Figure 11. Aerial photo of Cleawox Lake, October 1980. Photo by the author.

Figure 12. Aerial photo of Cleawox Lake, September 1989. Photo by the author.

Figure 13. Aerial photo of Cleawox Lake, August 1990. Photo by the author.

I have tracked this process over the past 40 years, photographing the lake and its encroaching dune from both the ground and the air (Figures 9-13 showing stages of dune migration between 1973 and 1990). During that period, hundreds of thousands if not a million or more park visitors have scrambled up the face of the dune to its summit before sliding, striding, or galloping back down toward the lake, pushing sand ahead of them as they descended, with many repeating their descents (Figure 14). In recent years, dune users have introduced the sandboard, a surfboard-like device that further "bulldozes" sand toward the lake. Sandboarding has become a major attraction, advertised in travel brochures and in other media. The boards are readily accessible, sold or rented by vendors outside the park.

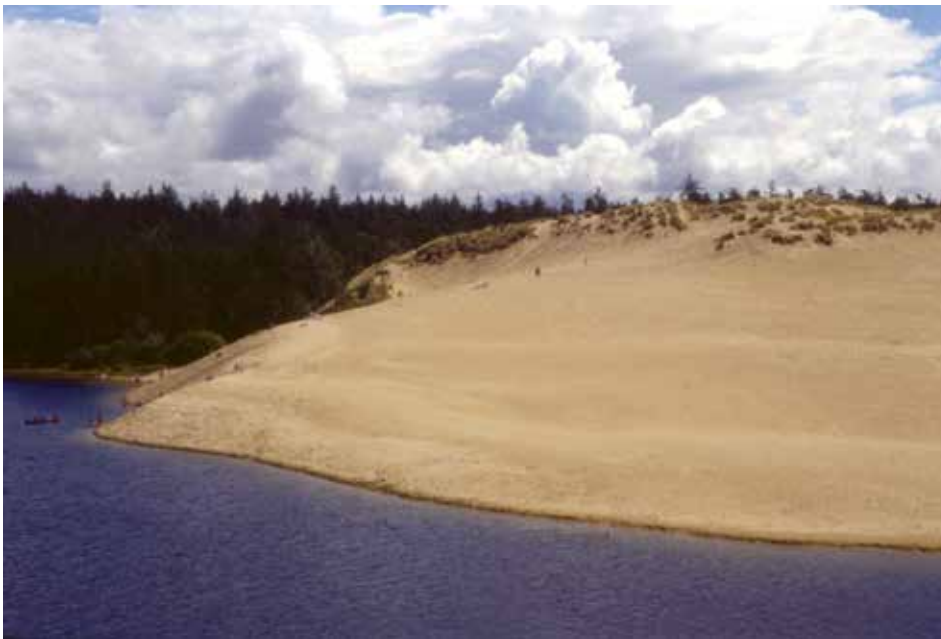
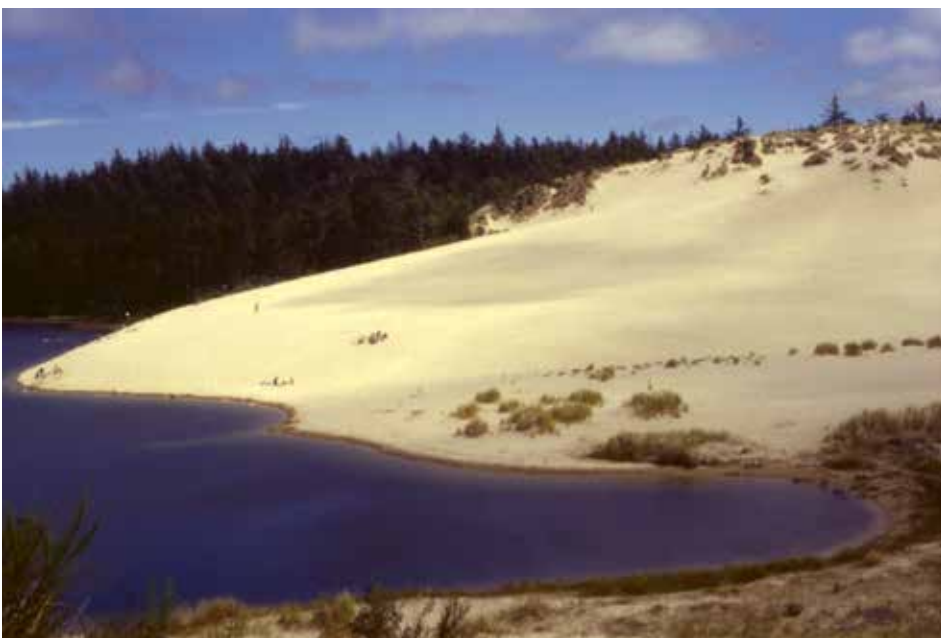
Figure 15. Side profile of south-shore dune looking east, August 1990. Photo by the author.

Figure 16. Side profile of south-shore dune looking east, July 2000. Photo by the author.

Dr. Joseph Miller Jr., the Portland physician who single-handedly halted illegal and destructive industrial logging in Oregon's Bull Run Watershed, the City of Portland's primary source of municipal drinking water, often said that battles to protect and preserve environmental treasures were won by educating the public. At Cleawox Lake, unfortunately, the public was not educated about how their footprints, actually and metaphorically, trampled the dune to a near-level profile (Figures 15 and 16), partially filling the lake and causing irreparable ecological harm.
