Student Corner

Restoration efforts respond to climate change conditions in the Duck Harbor Basin of the Herring River, Wellfleet, MA

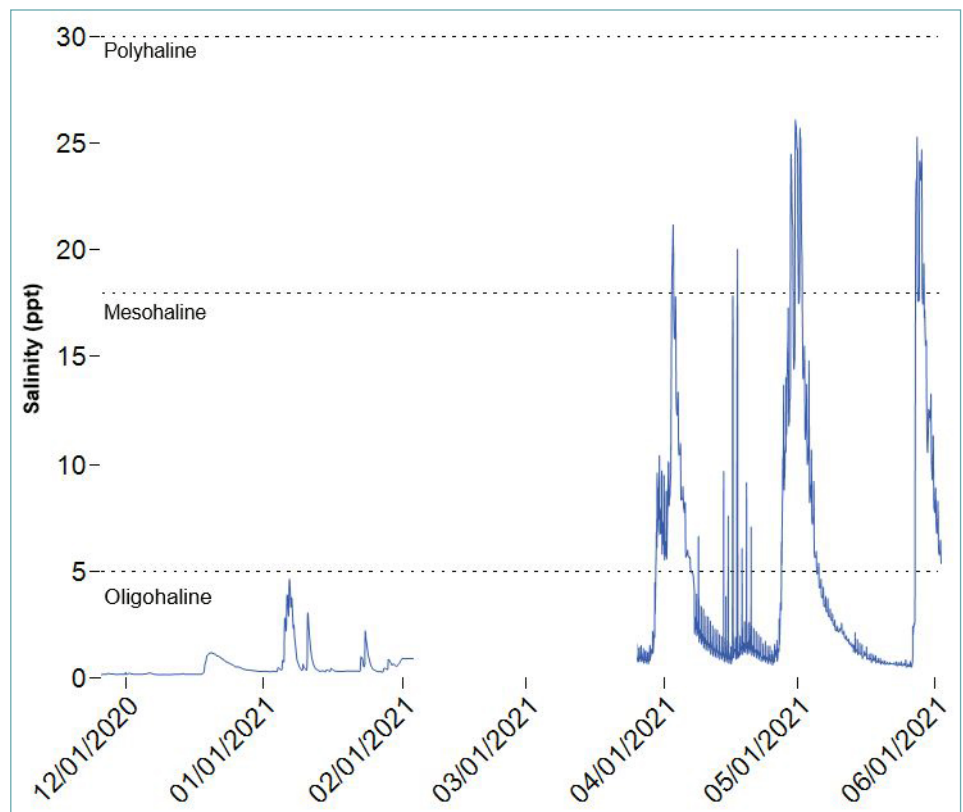
Figure 2. A continuous data logger within the Herring River initially detected the Duck Harbor tidal breach in December 2020 into February of 2021. In April 2021, the changes in salinity (ppt) from oligohaline to mesohaline and polyhaline during overwash events were evident within the Herring River Main stem.

In the fall of 2020, anecdotal reports of a tidal breach in the Duck Harbor dunes adjacent to Cape Cod Bay were reported and became evident by the winter of 2020 into 2021. As a result of rising sea levels in the adjacent Cape Cod Bay, the tidal breach allowed seawater from the bay to overwash and naturally inundate the low-lying wetland behind the dunes. Once the seawater overwashed into the Duck Harbor basin, the seawater flowed into the immediately adjacent freshwater portions of the Herring River through dilapidated mosquito ditches. The influx of seawater into the Herring River was detected on data loggers over a mile away from the breach and recorded the shift from oligohaline (0.5-5 ppt) to mesohaline (5- 18 ppt) and polyhaline (18-30 ppt) conditions (Figure 2). Since the initial breach reports, monthly higher high tides repeatedly overwash Duck Harbor beach and saltwater from Cape Cod Bay enters the upper Herring River and eventually exits out the dike.

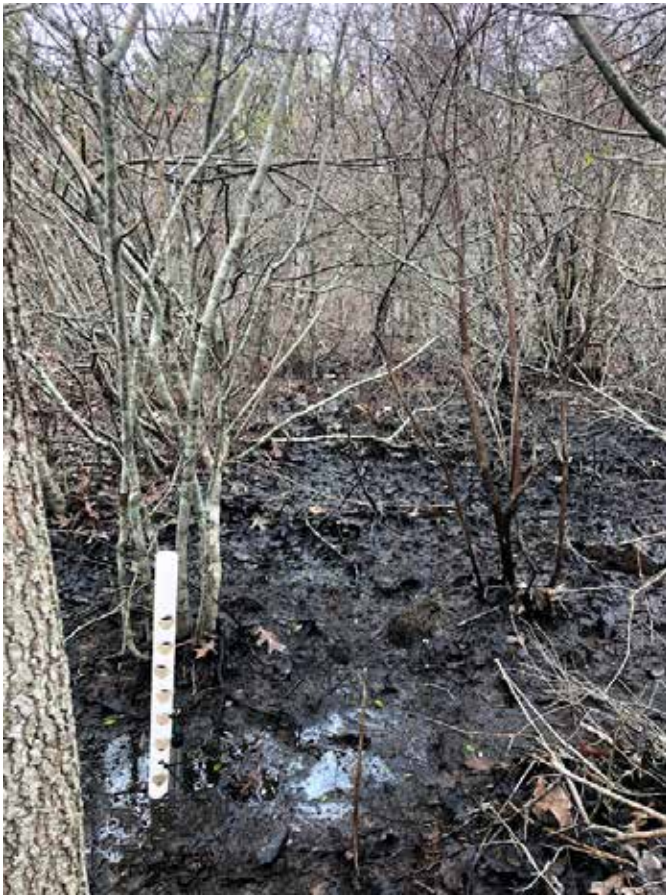
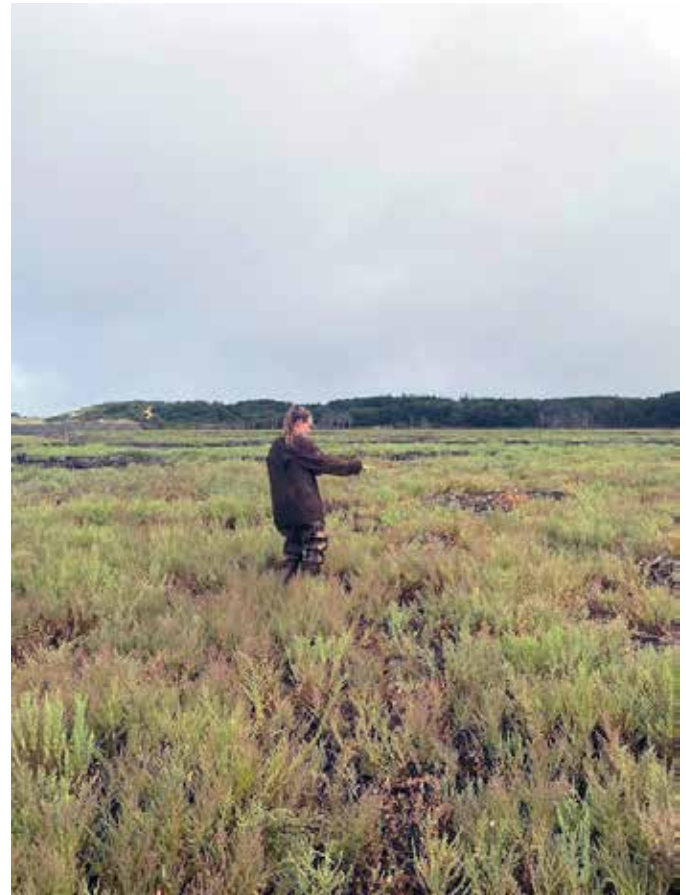
Figure 3. (Left) Low-lying wetland shrubs in the Duck Harbor basin in 2021 prior to the manual removal of trees. (Right) Early colonization of seablite in the first growing season in the Duck Harbor basin post manual removal of trees.

beneath the remnants of the pitch pine forest. In a proactive effort to accelerate the recolonization of early successional salt marsh species in the basin, the dead standing pitch pines were manually cleared in the winter of 2023 and the wood chips were used as a substrate for the future marsh platform. Once light was able to penetrate the basin floor, early marsh colonizers, like sea blite (*Suaeda sp.*), dominated the basin within the first growing season to begin the foundation for a hopeful trajectory toward self-sustaining salt marsh habitat (Figure 3). In addition to the immediate biological response of the plant community, American eels have been documented within the main marsh channel that transports seawater across the Duck Harbor basin.
