From green to blue: Working together to restore Lake Kanasatka's crystal clear water

Kevin Kelly, Christine Wallace, and Lisa Hutchinson

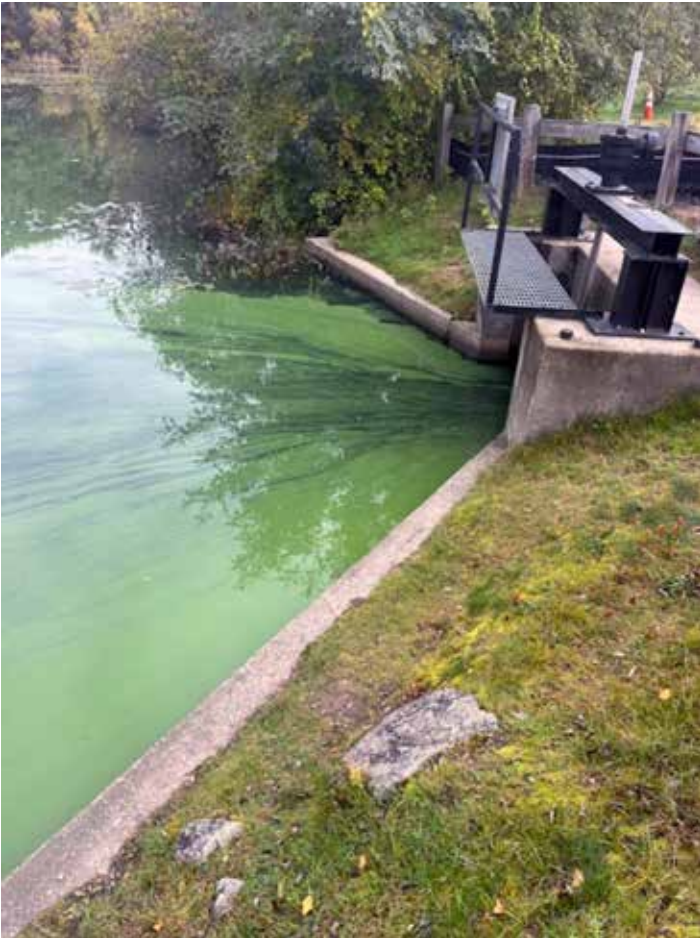
Figure 2. Cyanobacteria bloom accumulating above the Lake Kanasatka Dam.

Lake Kanasatka is a 353-acre body of water in the Lakes Region of New Hampshire. This lake and other lakes across the 4,528-acre watershed have had a long history of excellent water quality. In August of 2020, Lake Kanasatka residents and visitors alike, noticed something concerning about the water quality throughout the lake. Unlike more common cyanobacteria blooms, with telltale signs of colored scums near or along shore, Kanasatka had turned a bright fluorescent green (Figure 1). Water clarity was also negatively impacted. After testing water samples, New Hampshire Department of Environmental Services (NHDES) issued a cyanobacteria advisory based on cell concentrations exceeding the 70,000 cells/ml threshold. Over the next three years, Kanasatka experienced cyanobacteria advisories ranging from 24 days up to 121 days in a given year, culminating in a thick lake-wide bloom in October 2023 which spilled over a dam and into Lake Winnepesaukee, the state's largest lake (Figure 2 and Figure 3).

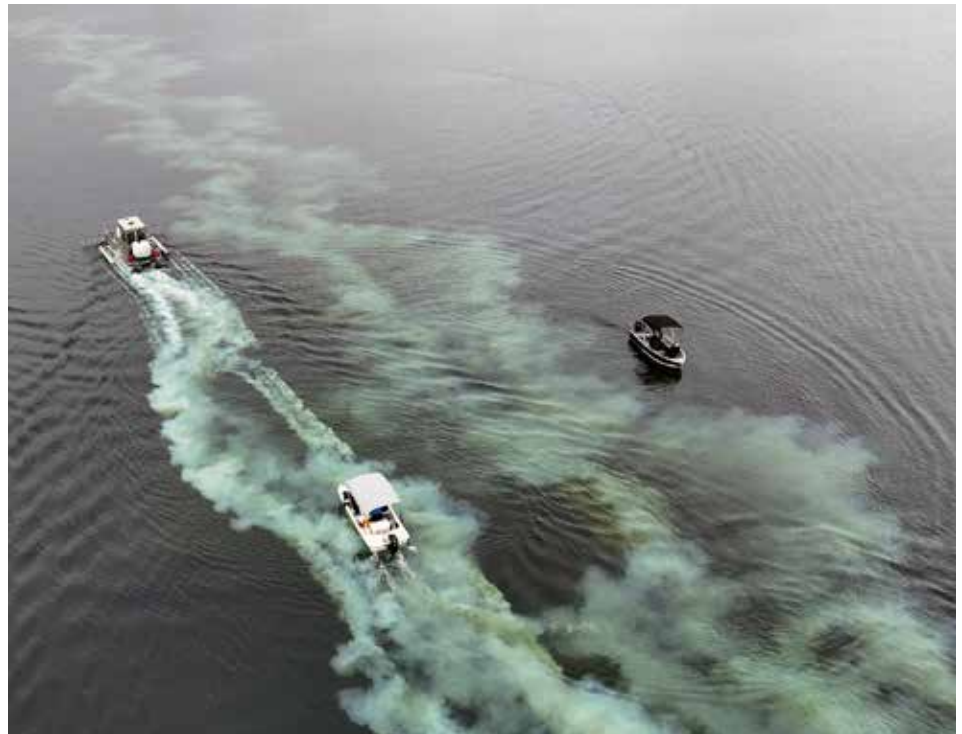
Figure 4. Lake Kanasatka aluminum treatment. Photo Credit: Bill Gassman

After much of the watershed work was completed or at least underway, LKWA completed an alum treatment (Figure 4) with funds raised by the lake community and with a grant from the State of New Hampshire in May of 2024. The aluminum compound settles on the bottom sediments and binds to the phosphorus, preventing it from being released back into the water column. The alum treatment successfully achieved its goal through the first season, and monitoring will continue to ensure that a durable reduction of internal loading is maintained (again, with the understanding that continued watershed work was necessary to implement and maintain). Throughout the remaining 2024 season, Kanasatka experienced beautifully clear water (up to 9.3 meters) with no cyanobacteria advisories. The longevity of the treatment depends on us. Lake

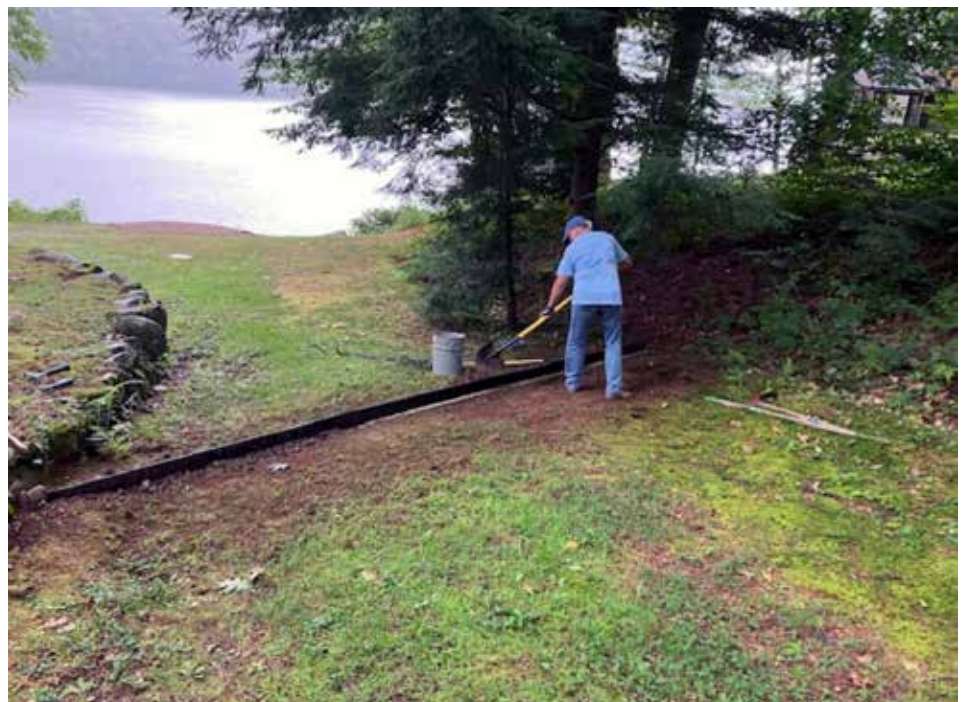
Figure 5. Lake resident installing a razor for runoff control.

- A unique stormwater management technique being used to divert stormwater from gravel driveways and foot paths, into suitable infiltration, was discovered when two residents were visiting an Audubon facility in Maine. These devices are called water razors, rubber razors, or water bars (Figure 5). They consist of a rubber "blade" made from recycled conveyor belt material that is sandwiched between and supported by two 2"x6" pressure treated wooden boards. The device is embedded in the surface of a gravel or dirt driveway or path so that only the four-inch blade is exposed (Figure 6). The rubber blade can be driven over, then it will spring back to its upright position. A razor is installed at a 30-degree angle across the path, so that it intercepts runoff and diverts it to an area where it can naturally infiltrate or flow to an existing structure like a rain garden, vegetated swale or dry well. Water razors are typically spaced 30 feet apart. They do require periodic sediment removal on the uphill side and are not recommended for areas managed by

snowplows. At the request of a homeowner, our lead watershed implementation volunteer evaluates the property for stormwater diversion opportunities, then fabricates the razors, and ensures proper installation. Property owners are charged for the cost of materials only, which is approximately \$5 per linear foot. If the property owner is not able to install the razor, volunteers do the work at no further cost. To date, our lead volunteer has supplied 37 water razors totaling nearly 400 linear feet to 16 separate properties.

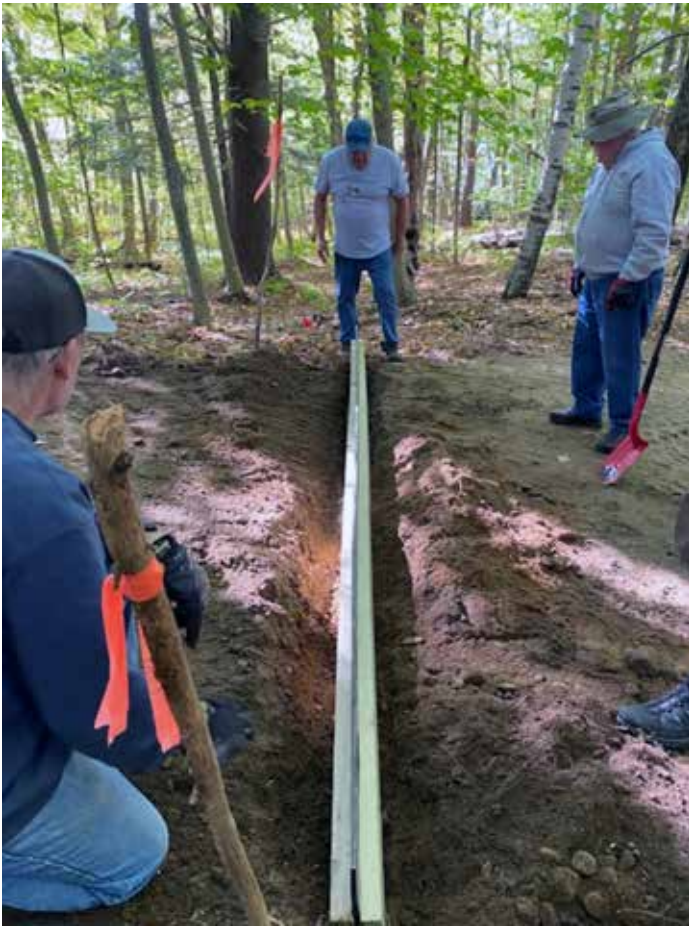
Figure 6. Lake resident installing a razor for runoff control.

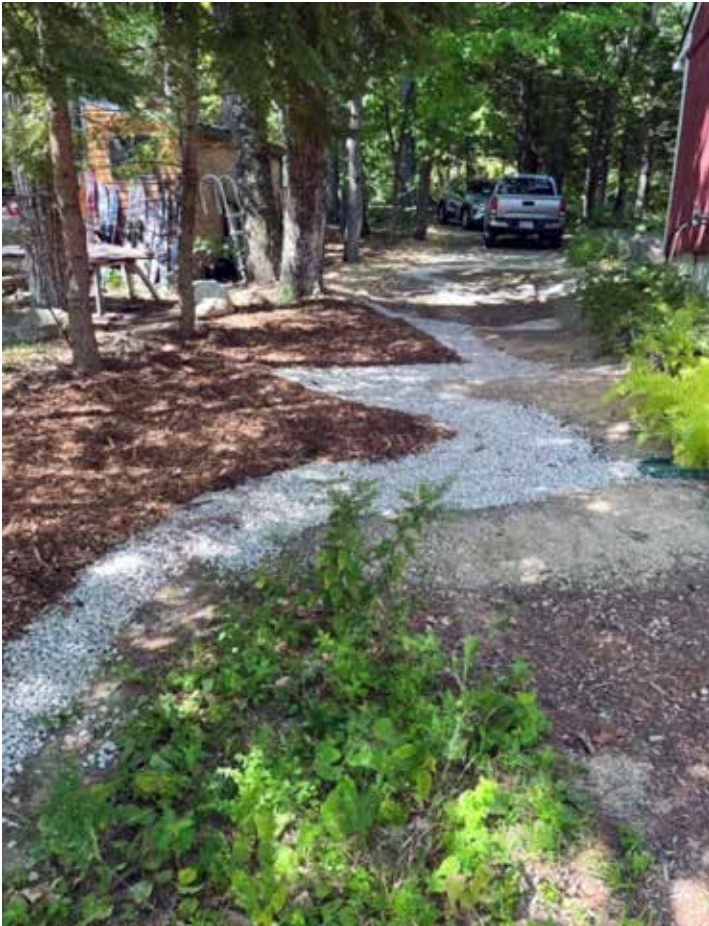
Figure 7. Lake resident's walkways to limit directional flow down the shoreline.
