Variable earth material, backshore erosion, and mitigation at Lewisville Lake, Texas

Paul F. Hudak

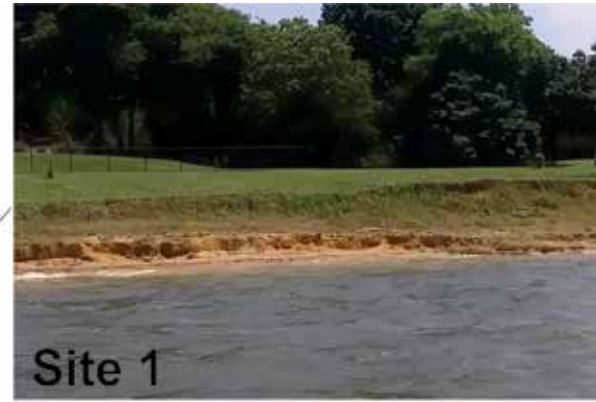
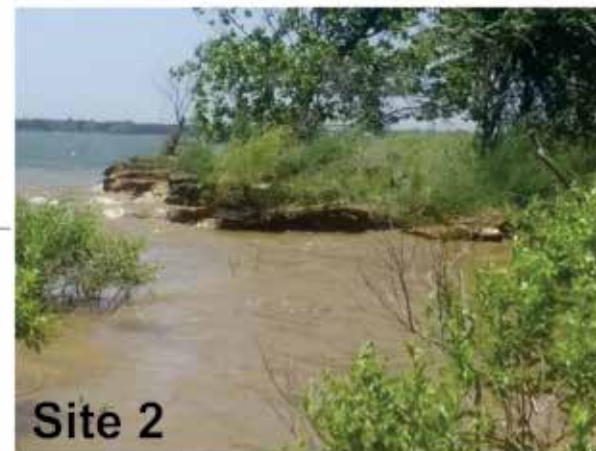
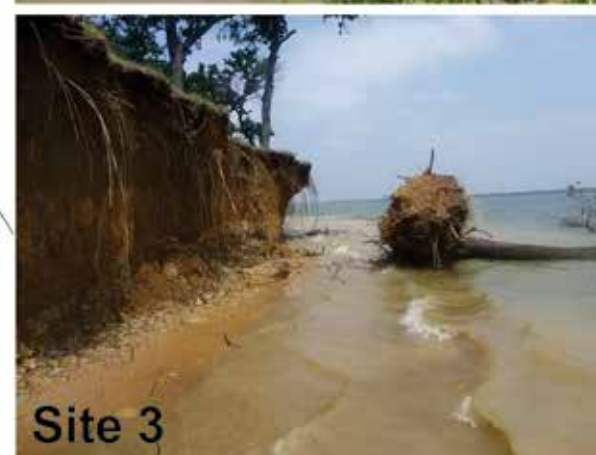
Figure 1. Sites 1 – terrace, 2 – sandstone, and 3 – shale.

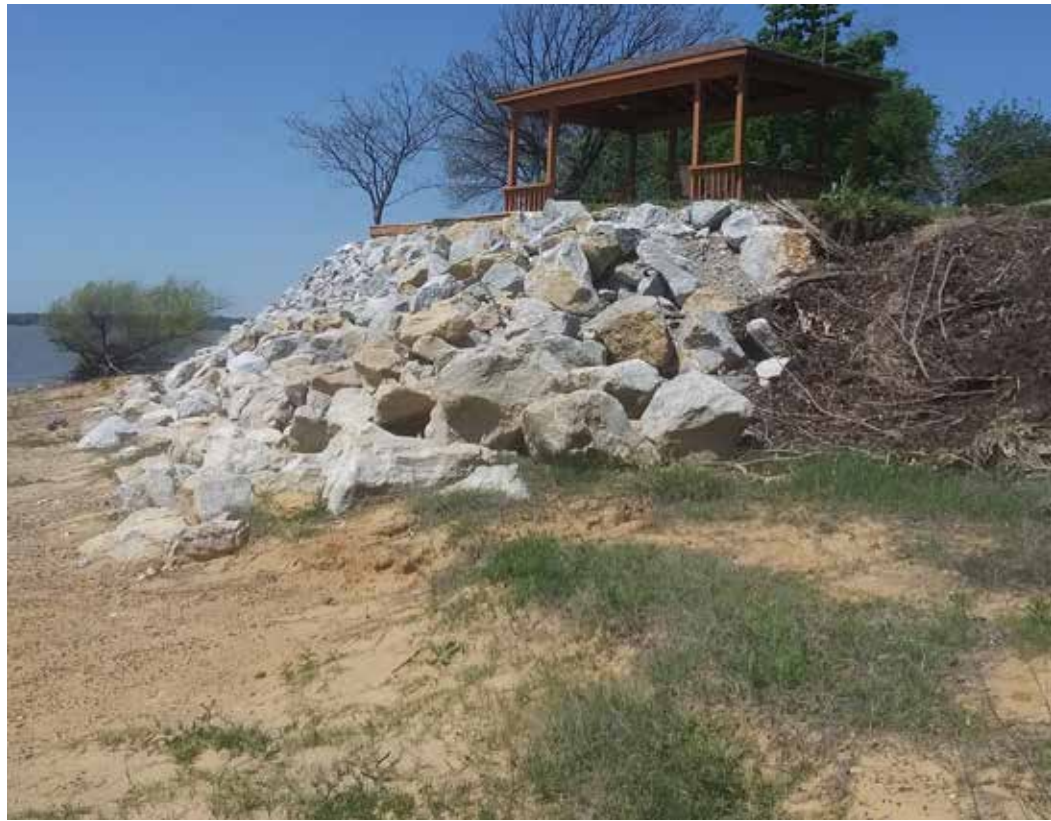
Limestone rip rap – typically, a rock blanket on landscape fabric – is used to slow erosion in the study area. However, waves tend to wash away sand and fine sediment beneath the fabric, which then sags and tears, causing rocks to subside and move downslope. Figure 2 shows the eastern edge of a 330-foot-long rock blanket at Site 1. Installed in 2020, the rock blanket has slowed erosion by about 0.7 feet/year when compared to adjacent, unprotected backshore. In 2024, rocks were added to fill gaps that formed in the original structure.

Figure 2. Rock blanket at Site 1; large (beige) rocks placed in 2020; smaller (grey) rocks added in 2024.

Better-prepared substrates beneath rip rap might lead to better outcomes. Such preparation might involve thorough compaction; wire mesh and sprayed concrete; or anchored geosynthetics less prone to sagging and tearing. Sturdy wire mesh around boulders (gabions) could prevent downhill movement but would still sag as the supporting substrate washed away. Hybrid approaches involving artificial structures such as gabions on augmented substrates, with intervening spots for native plants, might enhance aesthetics while providing better erosion control than sagging structures in the study area. For example, common buttonbush, which thrives along the wave-ravaged backshore, anchors soil while supporting various birds and insects.
